# Blackstone River Watershed Association

## Quinsigamond River Stream Team Shoreline Survey Report & Action Plan September 2009

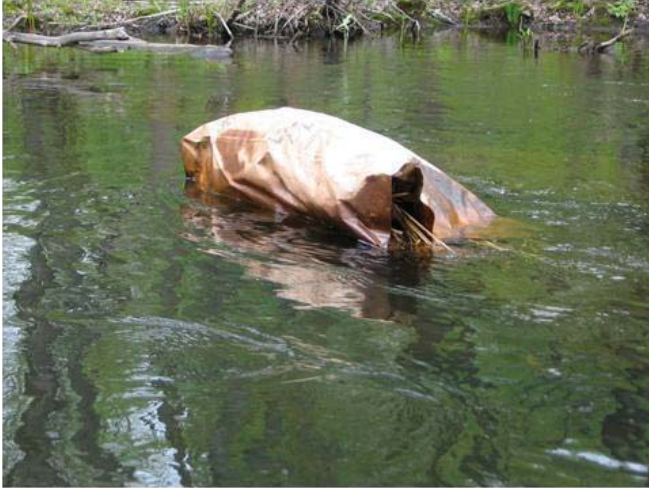
Another Vigoro bag of brush/clippings.

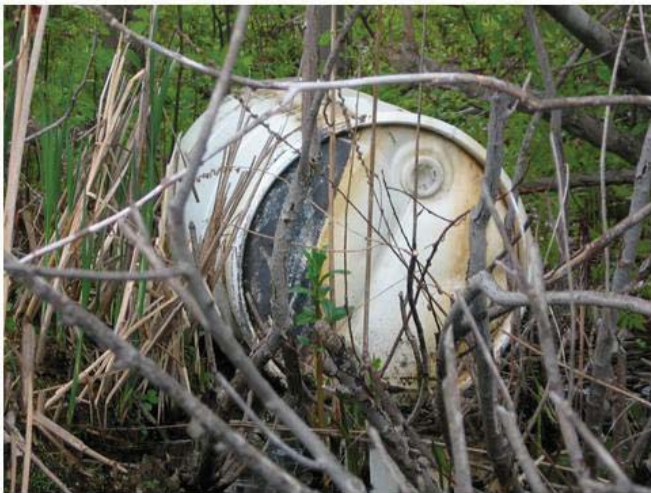
Suspicious barrel that we figured out its origin later.

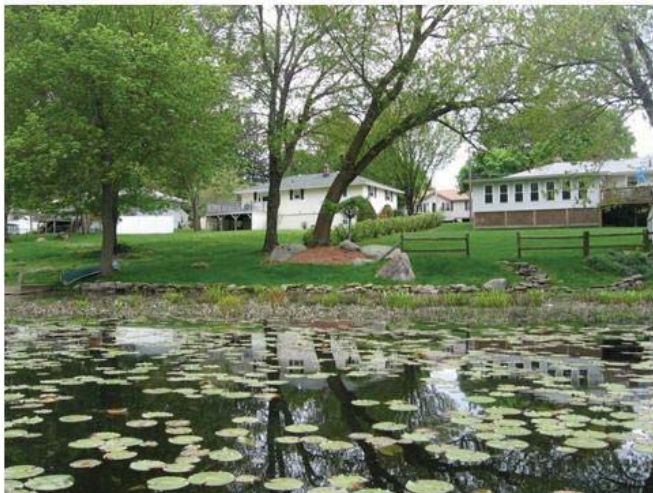
Lots of green, fertilized lawns going right down to the water...on the west, lower end of Hovey Pond.

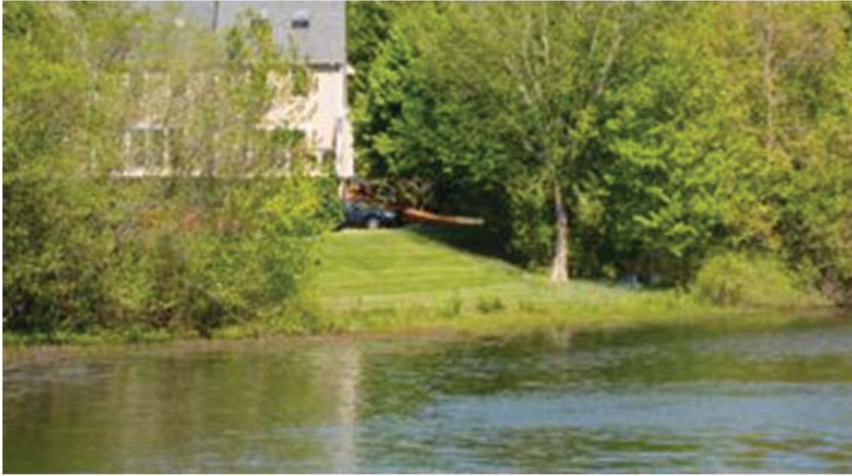
Vegetative buffer zone issues – Hovey Pond area

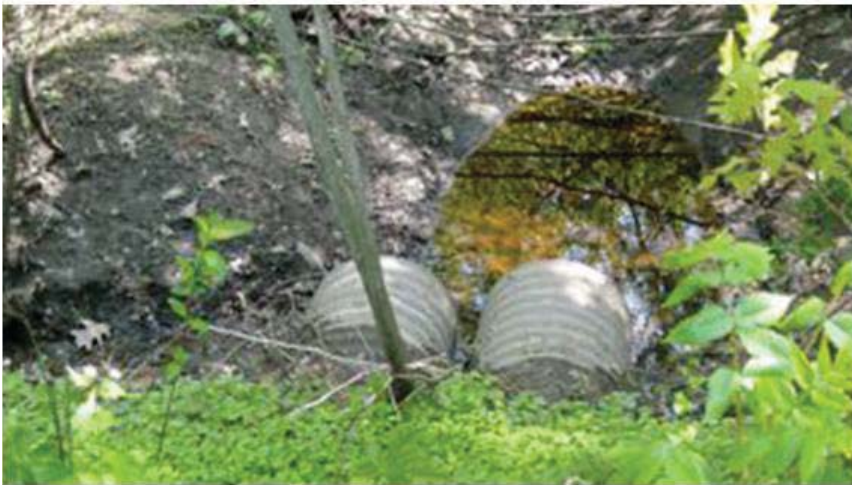
Several highway drains on Rte. 140 that fronts Washington Mills drain to a lower catch basin behind the Mill. Sand and silt collect in this area. It is noted that the State is responsible for the road salt, sand and maintenance of these drains. The drainage pipes cross under the RR easement. The responsibility for these belongs either to the State or the railroad. The pipe that exits into the wetland is silted up and has little drainage.

Silted up concrete  
pipes

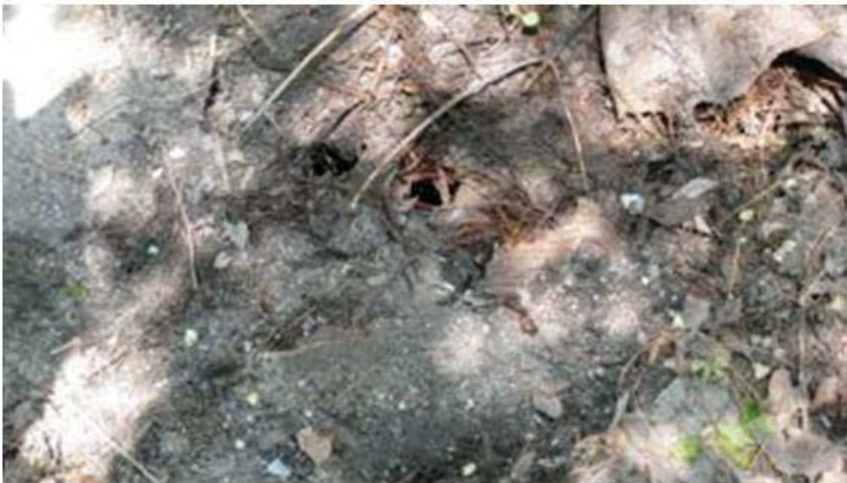
Clogged drain  
Route 140

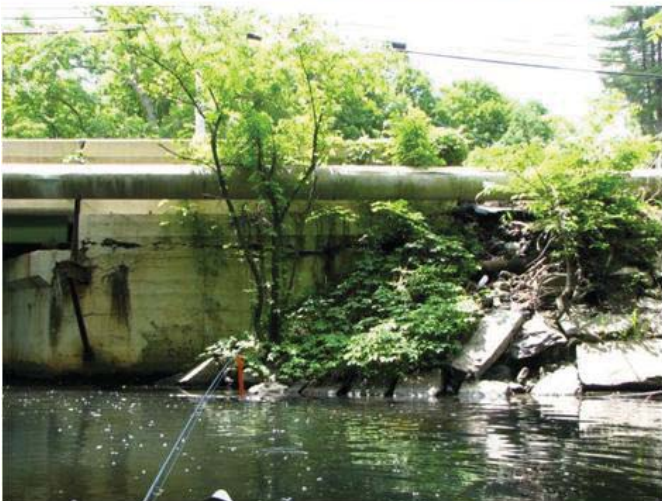
Right bank  
erosion (north  
side Rte 122  
bridge)

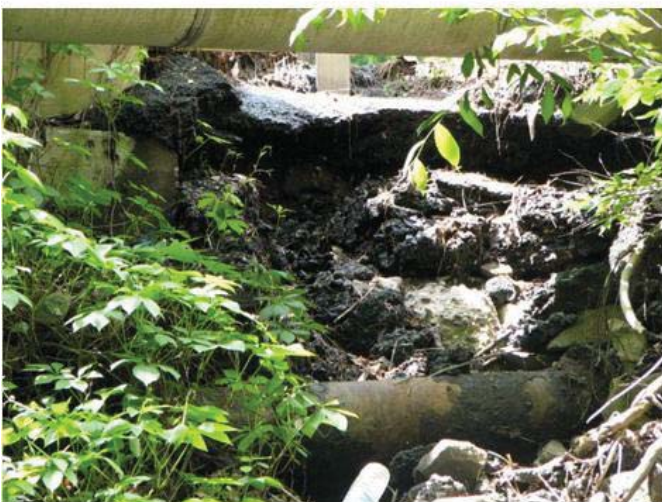
Close up of  
erosion

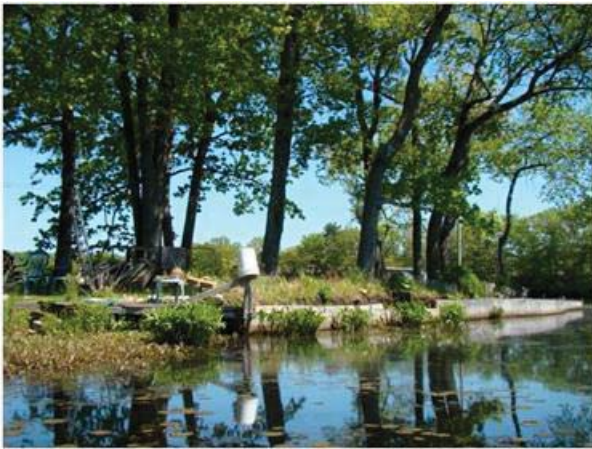
One of several houses with failing retaining walls

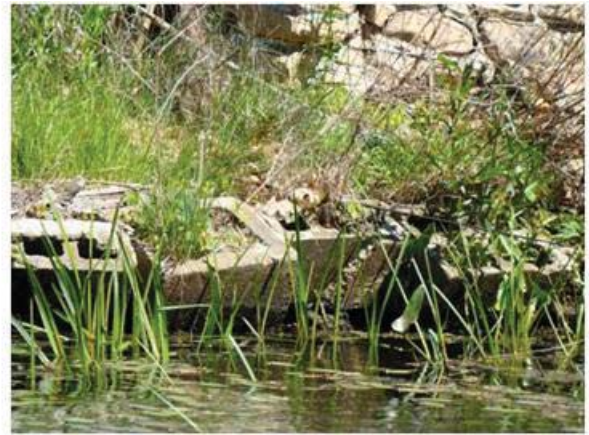
Close up of failed retaining wall

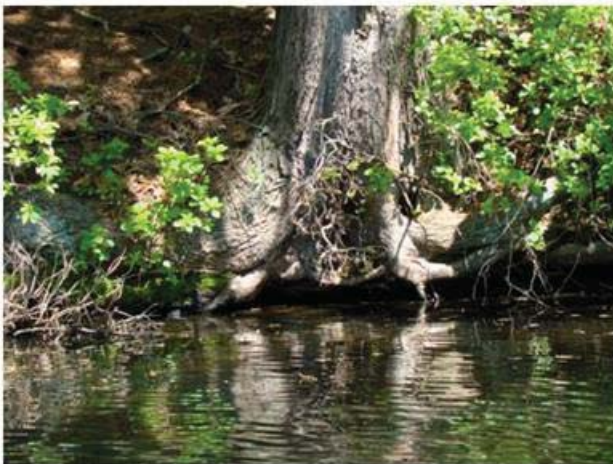
Bank erosion

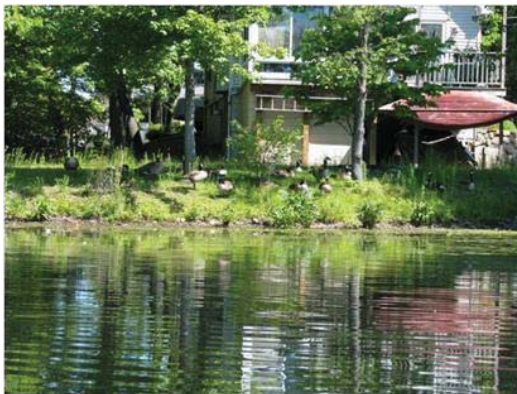
One of several houses with buffer zone issues—Lake Ripple (eastern segment)

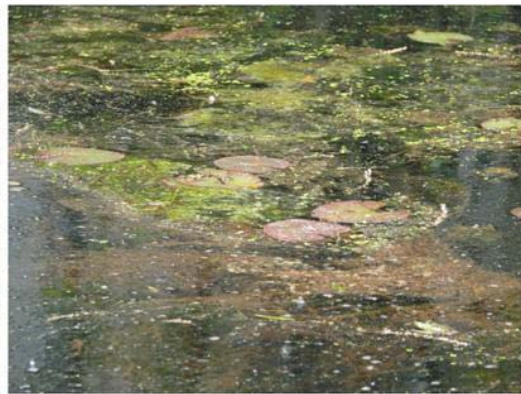
We also checked a creek at the northeast corner. It had lots of trash and a sheen over the water. There was also lots of overgrowth. Businesses nearby included a car wash. Also dumpsters and parking lots border this section.

Northeast corner—film and algae blooms

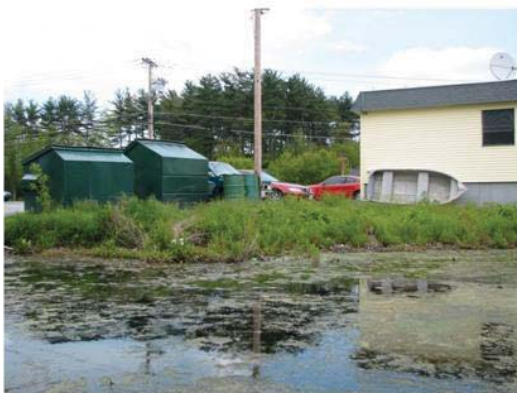
Several businesses (northeast corner) with dumpsters and 55 gallon drums near water

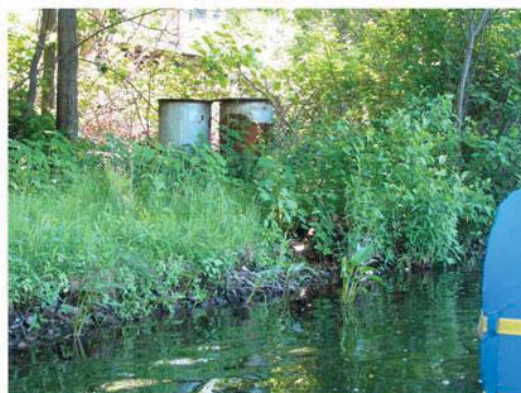
55 gallon drums along river bank

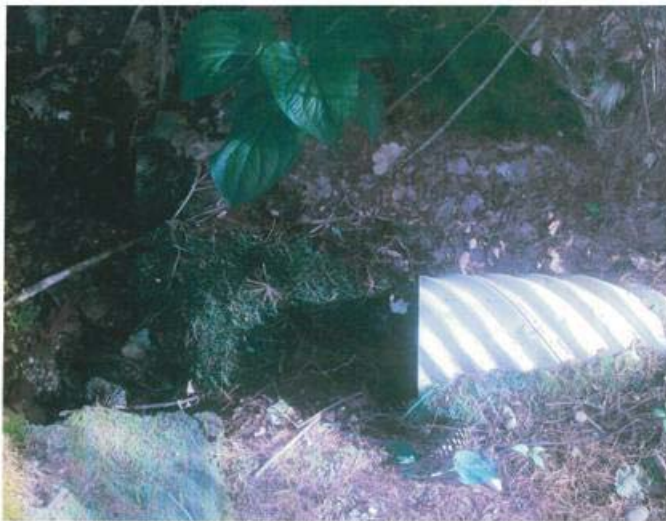
Outflow from soccer field drainage  
– very green moss

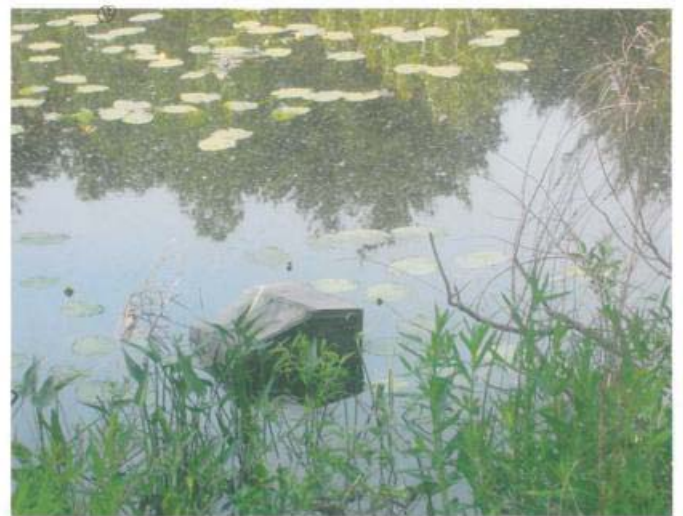
Old TV dumped in river

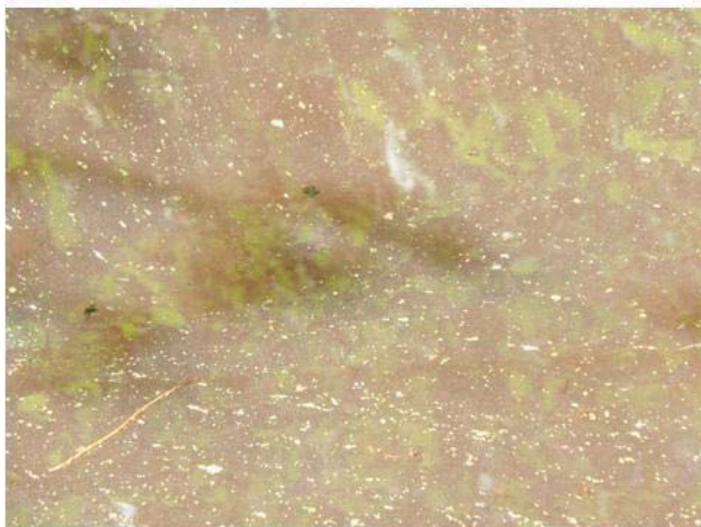
Downstream river  
bottom consists of  
dark green algae  
for ½ mile

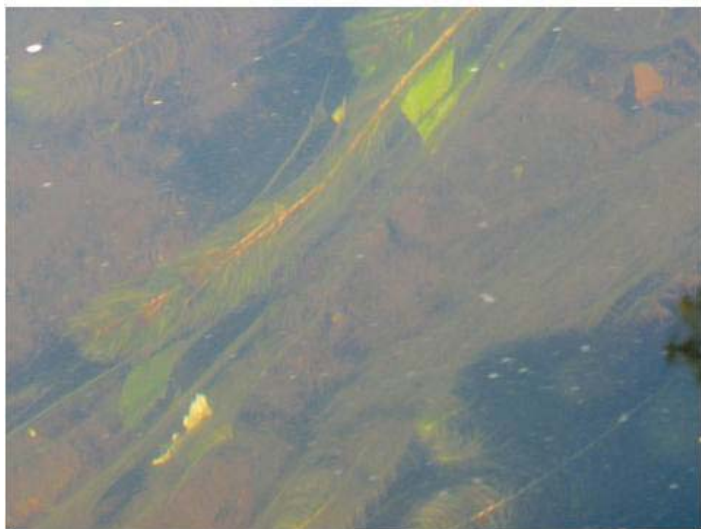
Thick patches of  
milfoil

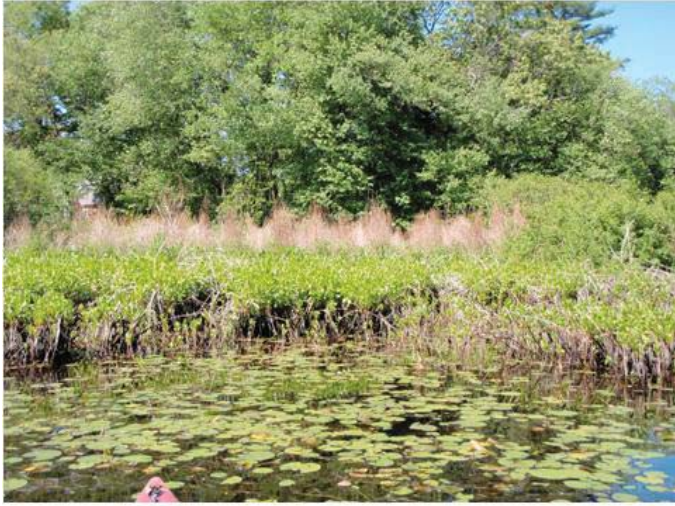
Downstream from  
Brigham Hill Road  
– wetland areas  
infested with  
purple loosestrife

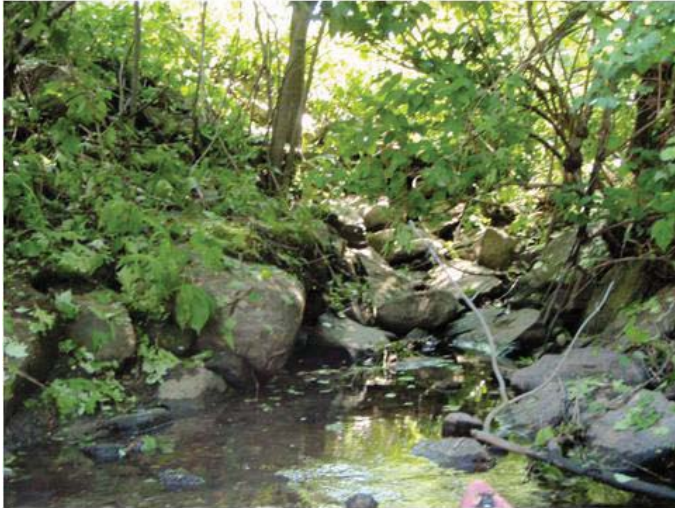
On the west (right) side of the river, on the downstream side of Brigham Hill Road a small stream enters the river after passing through a marsh adjacent to the river. The water entering the river from this stream appears to be cloudy and milky colored and creates a cloudy plume in the river that is noticeable for at least 100 yards downstream. The land alongside the river is mostly wooded and undeveloped throughout this section. Two more open wetland areas border the river farther downstream in this section; both are heavily infested with purple loosestrife.

River inlet – water  
appearance  
cloudy with plume  
for 100 yards

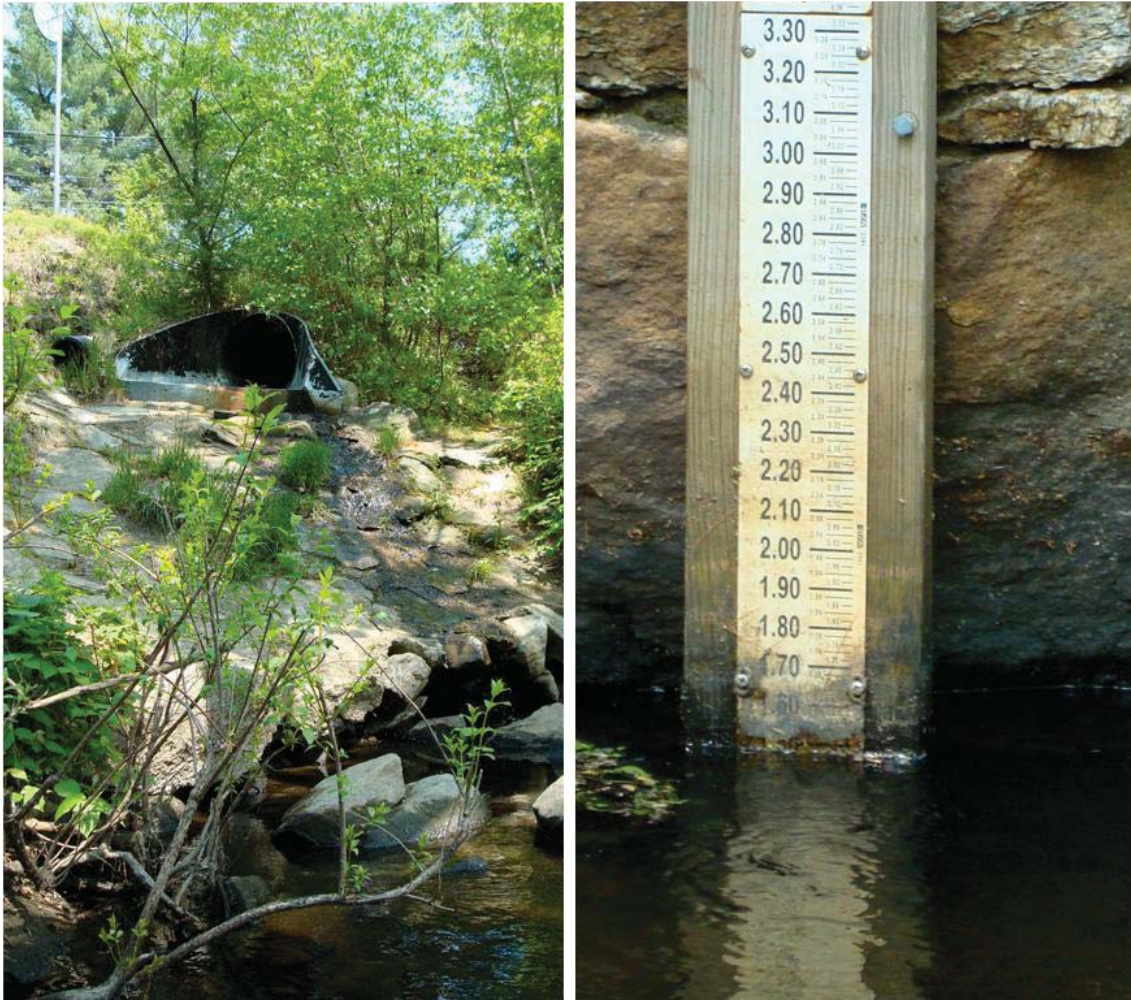
Two areas of water running from pipes into the river are noted on the map. Water appeared clear and odorless. Water flows constantly, even during dry weather.

Pleasant Street Bridge – (left) drain pipe has dry weather discharge (right) water depth at time of survey

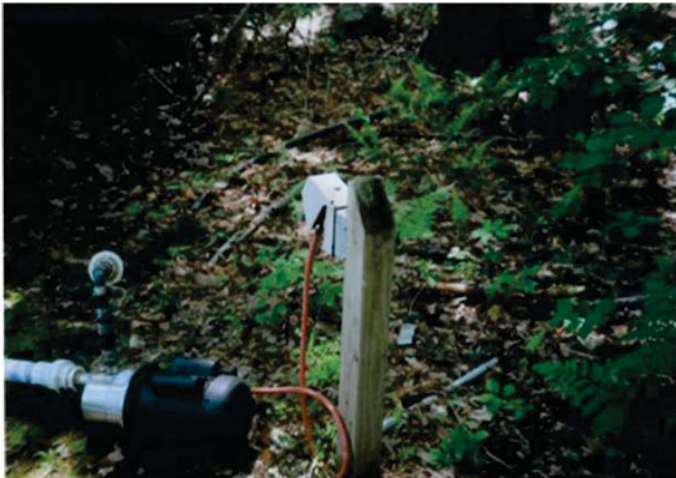
Observed first of several "pumping stations" with an electrical conduit coming from the residential area leading to a pump at the water's edge. An estimated 4" PVC pipe ran from the water to a hose that goes underground at the top of ridge behind the houses. At this point, the stream is ~ 20' wide. Opposite bank (left) had plowed fields behind houses and road.

One of several  
pumping stations  
found along this  
stretch

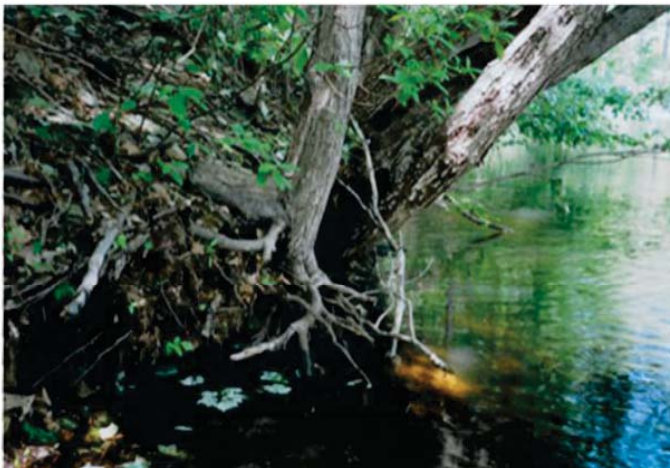
Eroded and  
undercut  
embankment

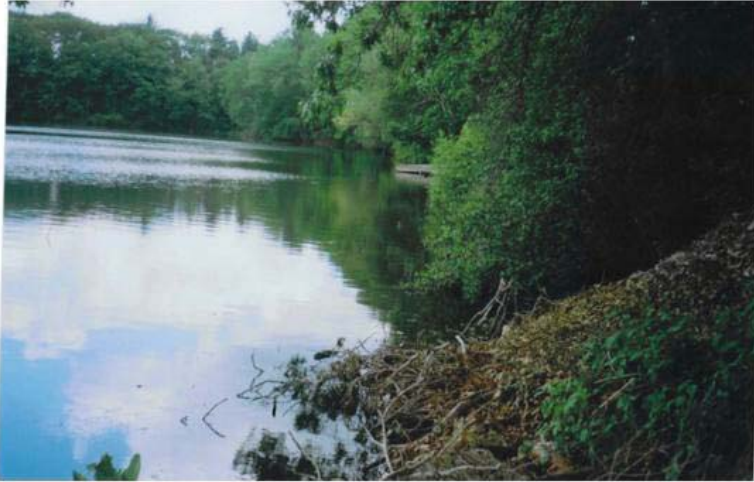
Yard debris  
dumped near  
river's edge

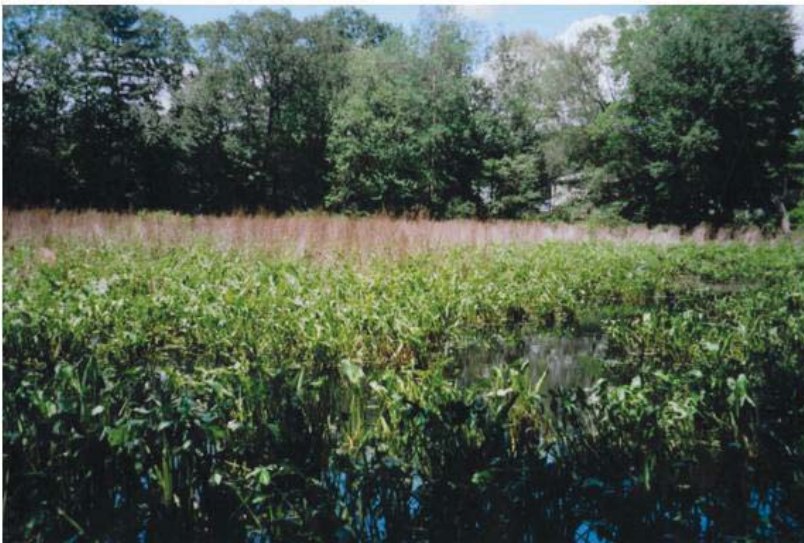
Wetland  
vegetation  
including purple  
loosestrife
