# Blackstone River Watershed Association

## West River Stream Team

### Shoreline Survey Report & Action Plan

June 30, 2007

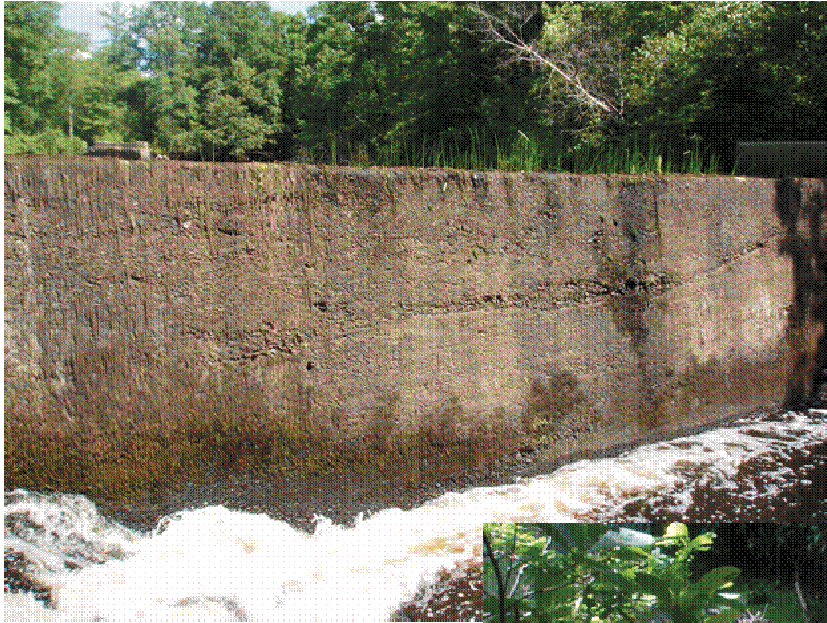
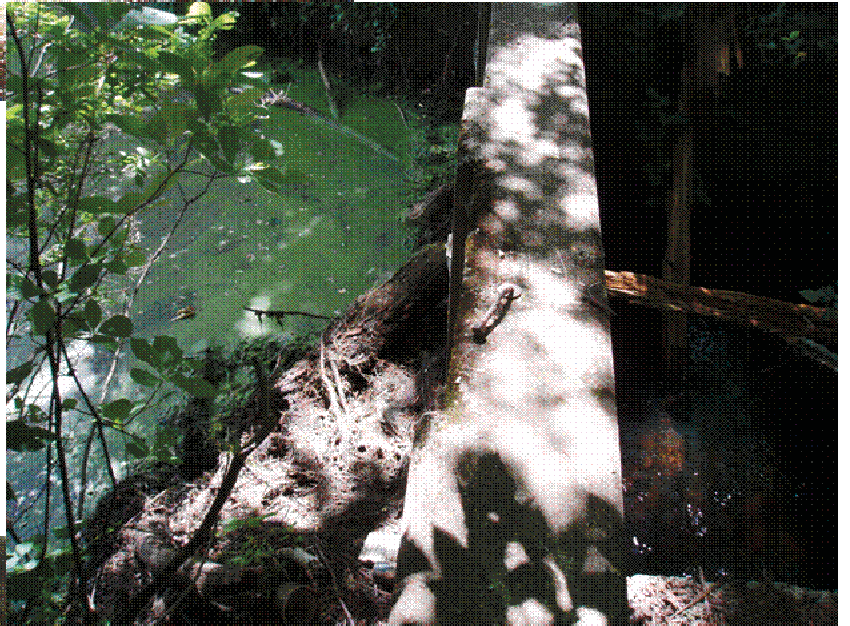
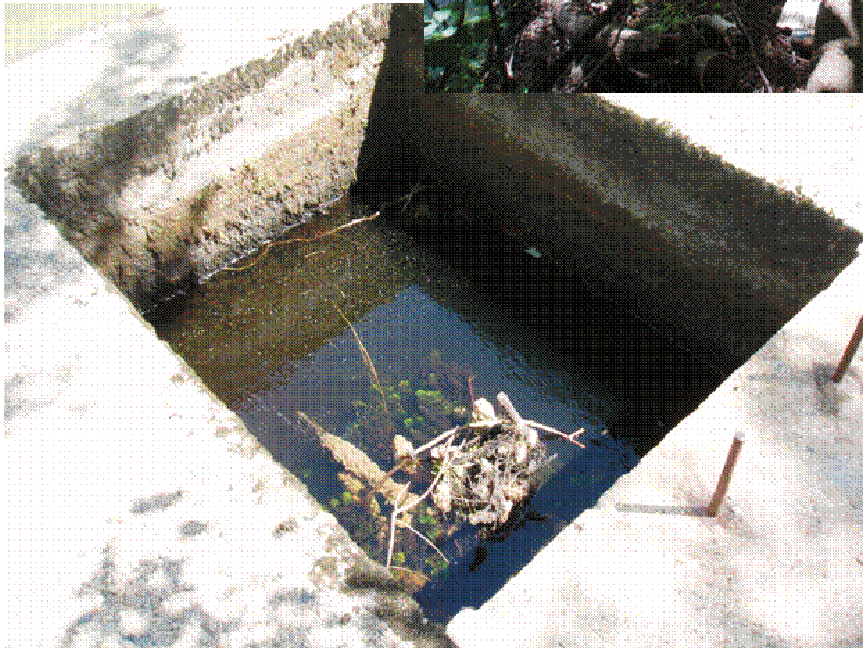
The surveyor inspected the concrete dam and noticed that the concrete was crumbling. The remains of a release gate was blocked with sticks, logs and other organic debris. An old canal gate by West River Road was dammed up with debris. The surveyor assumed that the gates were removed in the past to keep pressure off the aging dam but the blockages are again adding pressure to the dam.

The dam is upstream from the old Wacantuck Mill, the Uxbridge Town Wells and several residences. If the dam were to break, there would be a significant impact on the Town Wells and residences. Surveyor suggested maintenance and repair of the dam.

- Notify The Department of Conservation and Recreation's Office of Dam Safety about the failing dam at Wacantuck Mill
- Follow up with mill owner to see if he will maintain it

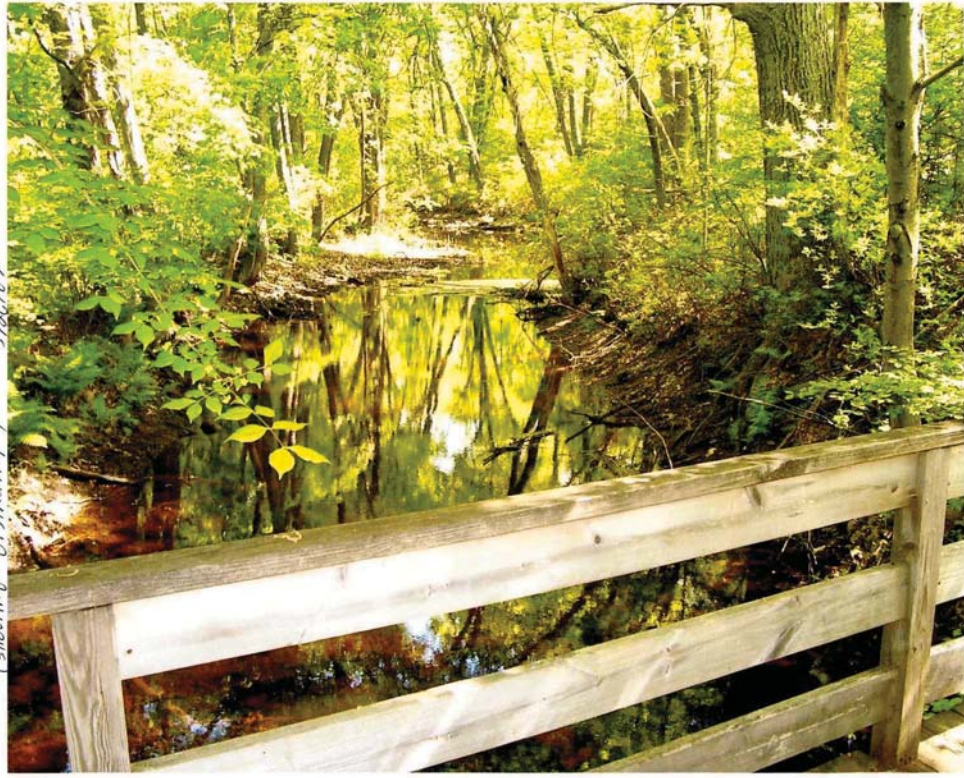
OLD CANAL THAT PARAZELLS BROWN'S TERRACE  
(SHOOTING UPSTREAM) 5/30/17
